## Center Mount Cooler

**Model : TCA113AE(OX, NX, OM, NM)**

## TCA AIR DEFROST MODEL 60HZ WITH EC MOTOR (1 SPEED)

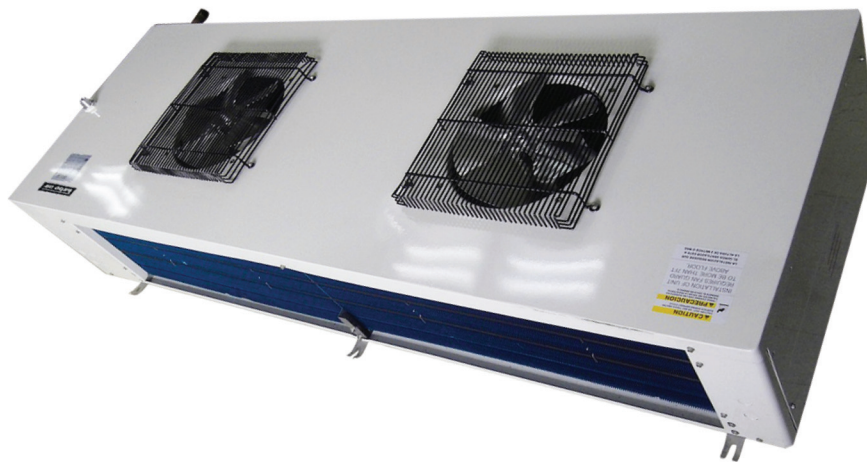
Blue Anti-Corrosion  
Hydrophobic Coated Fin.  
Air Pass Guard for Better  
Efficiency.

Inner Groove Copper Tube  
for Maximum Coil Efficiency.  
Mounted TXV, Solenoid,  
Thermostat(Optional).

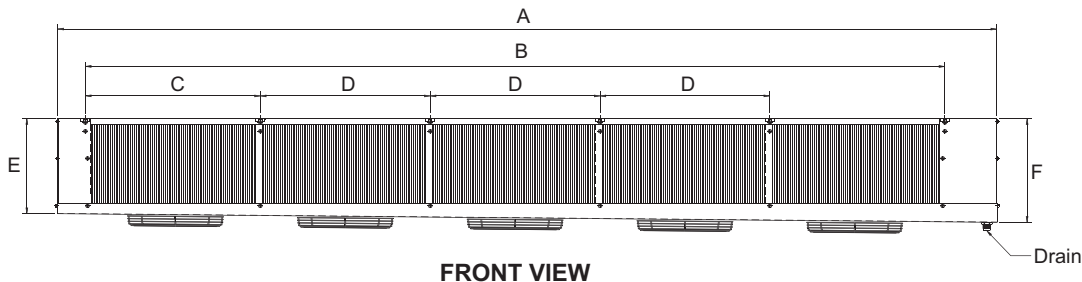
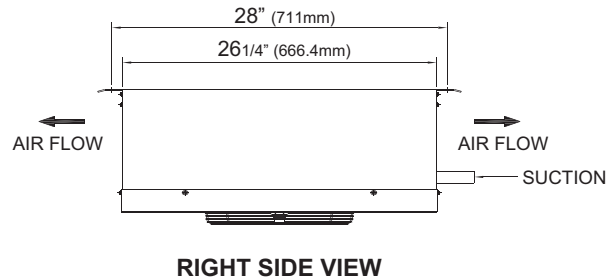
## PLAN VIEW

| No.<br>of Fans | Dimensions (Inches / mm) | | | | | |
| | A | B | C | D | E | F |
| 1 | 79.3 (2015) | 67.3 (1709.4) | - | - | 6.7 (171.3) | 7.9 (201.3) |

(unit : inch)
